WOOD DESTROYING PESTS AND ORGANISMS INSPECTION REPORT #: 20182184

BUILDING NO. 526	STREET 36TH AVE	CITY SANTA CURZ	ZIP 95062	Date of Inspection 09/27/2018	NUMBER OF PAGES 1 of 6
---------------------	--------------------	--------------------	--------------	----------------------------------	---------------------------

GENERAL DESCRIPTION: This is a one story, wood sided, single family residence with a raised foundation. It has no garage or carport and no patio. It has a composition roof and was occupied and furnished at the time of inspection.	Inspection Tag Posted: Under kitchen sink.
	Other Tags Posted:

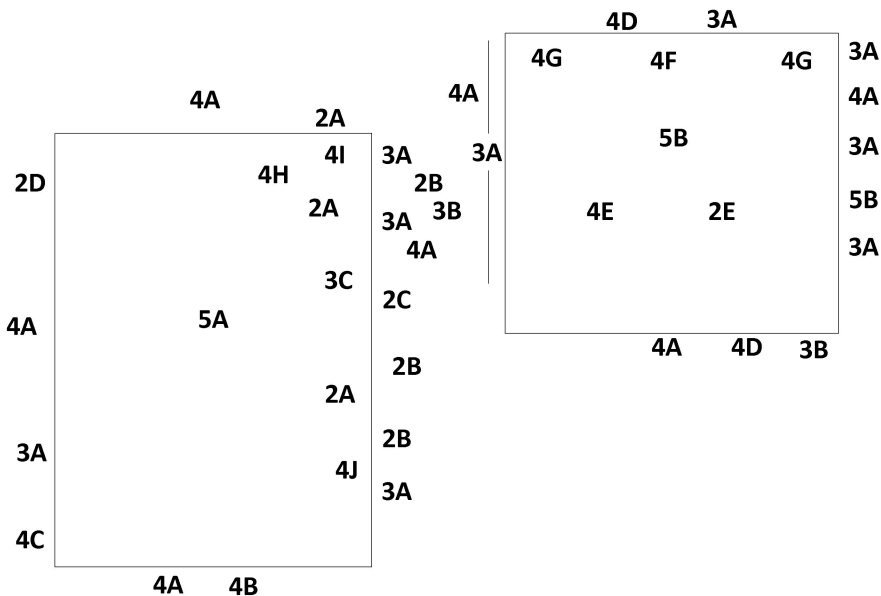
Key: 1 = Subterranean Termites 2 = Drywood Termites 3 = Fungus/Dryrot 4 = Other Findings 5 = Further Inspection

FINDING AND RECOMMENDATION: 2A
 FINDING: (SECTION 1)
 EVIDENCE OF DRYWOOD TERMITES AS INDICATED BY 2A ON THE DIAGRAM. THE EVIDENCE NOTED IN THE RAFTER TAIL, FASCIA, CIELING, SIDING AND DOOR JAMB..

FINDING AND RECOMMENDATION: 2B
 FINDING (SECTION 1)
 DRYWOOD TERMITE DAMAGE WAS NOTED TO RAFTER TAILS.

FINDING AND RECOMMENDATION: 2C
 FINDING (SECTION 1)
 DRYWOOD TERMITE DAMAGE WAS NOTED TO SIDING.

FINDING AND RECOMMENDATION: 2D
 FINDING (SECTION 1)
 DRYWOOD TERMITE DAMAGE WAS NOTED TO DOOR JAMB.

FINDING (SECTION 1)
MINOR DRYWOOD TERMITE DAMAGE WAS NOTED TO CIELING.
RECOMMENDATION:
DAMAGE APPEARS TO SUPERFICIAL AND AREA APPEARS TO BE STRUCTURALLY SOUND.
ROUT OUT DAMAGE AND REPAIR AS NECESSARY.

FINDING: (SECTION 1)
FUNGUS DAMAGE INDICATED BY 3A ON DIAGRAM. THE FUNGUS DAMAGE WAS NOTED IN RAFTER TAILS
RECOMMENDATION:
REMOVE DAMAGED WOOD AND REPLACE WITH NEW WOOD IN TODAY'S AVAILABLE WIDTHS AND GRADES.

FINDING (SECTION ONE)
FUNGUS/DRY ROT DAMAGE WAS FOUND IN THE WINDOW TRIM AS INDICATED ON THE DIAGRAM

FINDING (SECTION ONE)
FUNGUS/DRY ROT DAMAGE WAS FOUND IN THE WINDOW SILL AS INDICATED ON THE DIAGRAM

FINDING: (SECTION 2)
EARTH TO WOOD CONTACT AS INDICATED BY 4B ON THE DIAGRAM. THE CONTACT WAS NOTED FRONT PORCH .

FINDING: (INFORMATION ONLY)
DRY WATER STAINS NOTED AS 4E ON THE DIAGRAM. THE STAINS WERE IN THE CIELING AT ART STUDIO . NO MOISTURE WAS NOTED.
RECOMMENDATION:
NONE. NOTED FOR INFORMATION ONLY. PERIODICALLY INSPECT AREA.
CONTACT THE APPROPRIATE LICENSED TRADES FOR MORE INFORMATION

FINDING (SECTION 2)
MOISTURE/MILDEW LIKE STAINS WERE NOTED AT CIELING AND WALLS AT ART STUDIO AS INDICATED BY 4F ON DIAGRAM.
RECOMMENDATION: CONTACT THE APPROPRIATE TRADES TO EVALUATE

FINDING: (SECTION 1)
MOISTURE DAMAGE AS INDICATED BY 4G ON DIAGRAM. THE MOISTURE DAMAGE WAS TO WALL AND CEILING AT ART STUDIO.
RECOMMENDATION:
REMOVE DAMAGED MATERIAL AND REPLACE WITH TODAY'S AVAILABLE MATERIALS.

FINDING: (SECTION 2)
THE COMMODE IS LOOSE IN THE GUEST BATHROOM. AS INDICATED BY 4H ON THE DIAGRAM.
RECOMMENDATION: RE-SECURE TO SEATING FLANGE AND TIGHTEN

FINDING: (INFORMATION ONLY)
DRY WATER STAINS NOTED AS 4J ON THE DIAGRAM. THE STAINS WERE IN THE WINDOW SILLS . NO MOISTURE WAS NOTED.
RECOMMENDATION:
NONE. NOTED FOR INFORMATION ONLY. PERIODICALLY INSPECT AREA.
CONTACT THE APPROPRIATE LICENSED TRADES FOR MORE INFORMATION

RECOMMENDATION: 2A
 RECOMMENDATION:
 FUMIGATE THE STRUCTURE(S) WITH (SULFURYL FLUORIDE) A FUMIGANT LETHAL TO DRYWOOD TERMITES. SEE THE OCCUPANTS FUMIGATION NOTICE FOR FURTHER DETAILS. THIS COMPANY IS NOT RESPONSIBLE FOR DELAYS OR SCHEDULE CHANGES DUE TO INCLEMENT WEATHER OR OTHER AGENCIES, NOR IS IT RESPONSIBLE FOR DAMAGE TO ROOF OR PLANTS AS A RESULT OF THE FUMIGATION. REFER TO THE OCCUPANT'S FUMIGATION NOTICE/PREPARATION SHEET (SENT SEPARATELY) FOR ADDITIONAL INFORMATION.

RECOMMENDATION: 2B
 RECOMMENDATION:
 REMOVE AND REPLACE OR REINFORCE AS NECESSARY WITH TODAY'S AVAILABLE WIDTHS AND GRADES.

RECOMMENDATION: 2C
 RECOMMENDATION:
 REMOVE AND REPLACE OR REINFORCE AS NECESSARY WITH TODAY'S AVAILABLE WIDTHS AND GRADES.

RECOMMENDATION:
REMOVE AND REPLACE OR REINFORCE AS NECESSARY WITH TODAY'S AVAILABLE WIDTHS AND GRADES.

RECOMMENDATION:
REVISE AREA TO BE FREE OF EARTH TO WOOD CONTACTS
